# **Glasshouse Mountains National Park (Coonowrin)**

*Risk Analysis considering  
Random/Natural Rockfall Incidence*

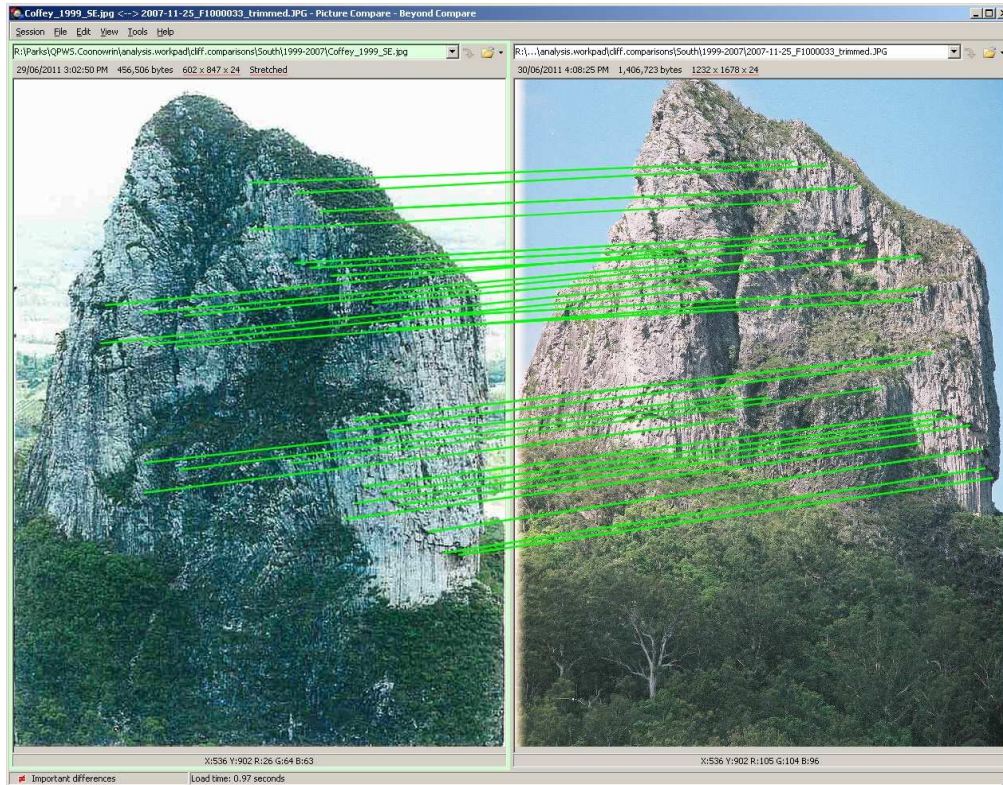
**Figure 22. South Face - Matched Features - 1999-2008 (first image from Coffey (Coonowrin) 1999 [1])**

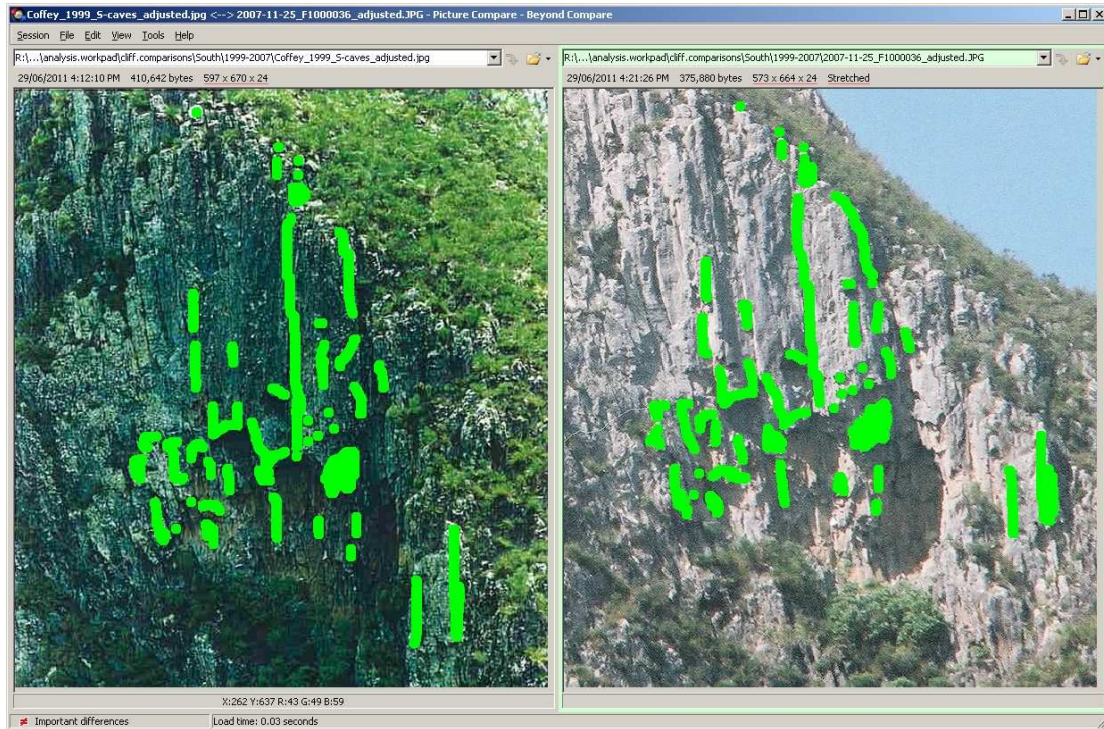
Figure 24. South Face Caves - Matched Features - 1999-2008 (first image from Coffey (Coonowrin) 1999 [1])

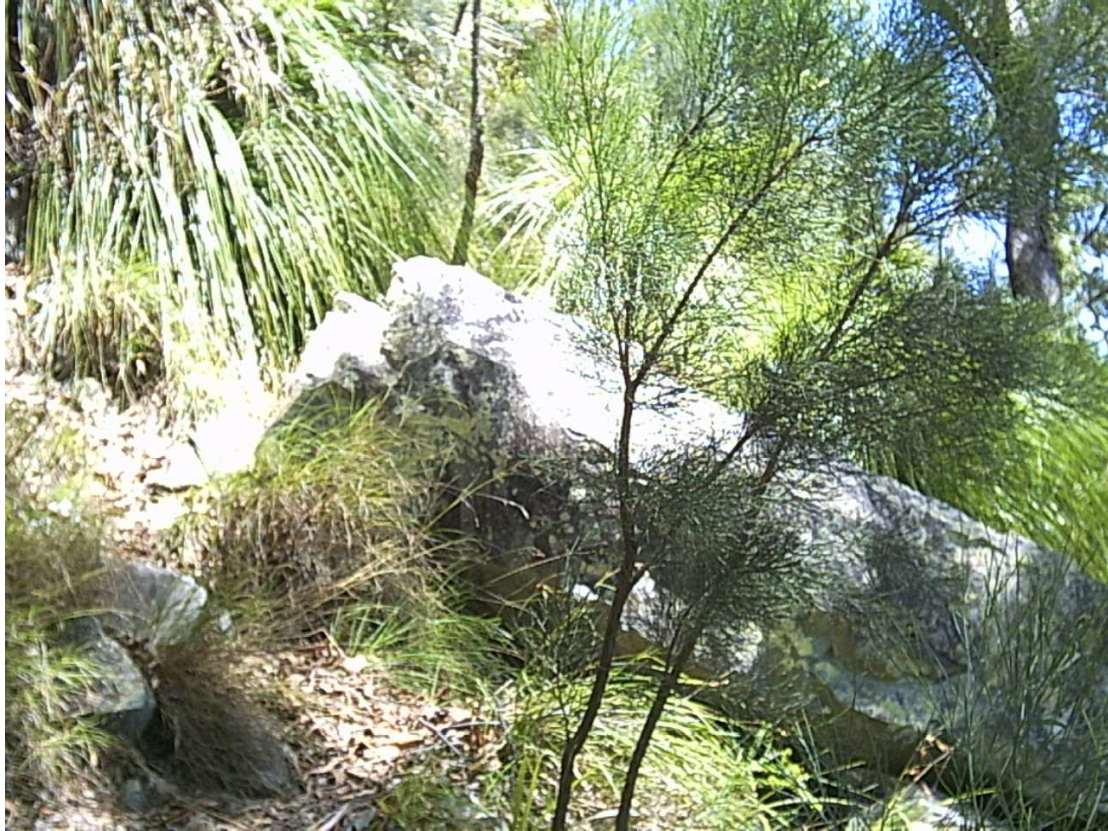
A single pillar, approximately 0.24 m<sup>3</sup> (est 1.5x0.4x0.4), was found on the slope approximately 20m from the base of the East cliffs, between the East and South East caves on 2008-11-23. This appeared to have some crushed grass and plants in an apparent path behind it, and it gave the impression of having fallen sometime in the recent year. The location was not expressly recorded, and in a later trip efforts to exactly locate it were unsuccessful. The source location of the pillar on the cliff line was not ascertained.

**Figure 96. Fallen Pillar, East face**

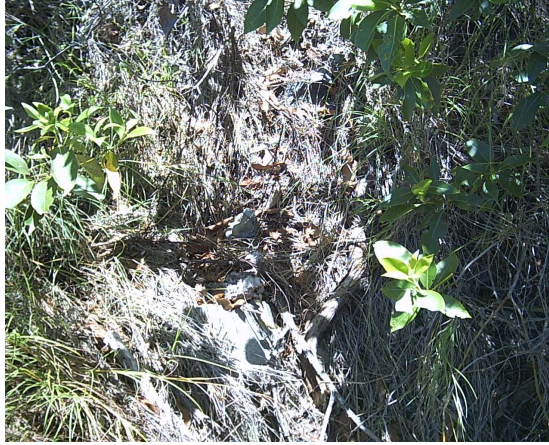
A single pillar, approximately 0.11 m<sup>3</sup> (est 1.2x0.3x0.3), broken into pieces, was found on the slope approximately 10m from the base of the East cliffs, some 10m North of the East caves on 2008-11-23. There were deformed plants and powdered debris and this appeared to have fallen sometime in the recent months. The source location of the pillar on the cliff line was not ascertained.

**Figure 97. Plant damage**

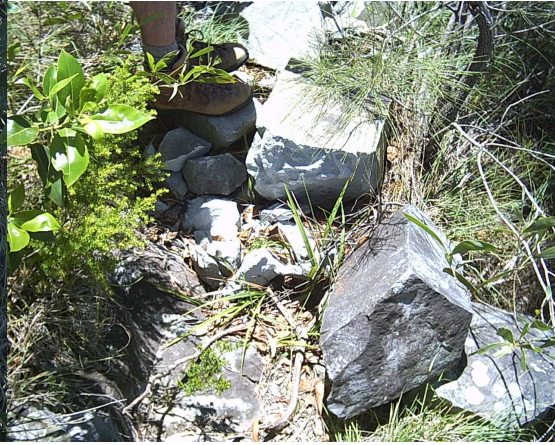
**Figure 98. Fallen Pillar, East face**

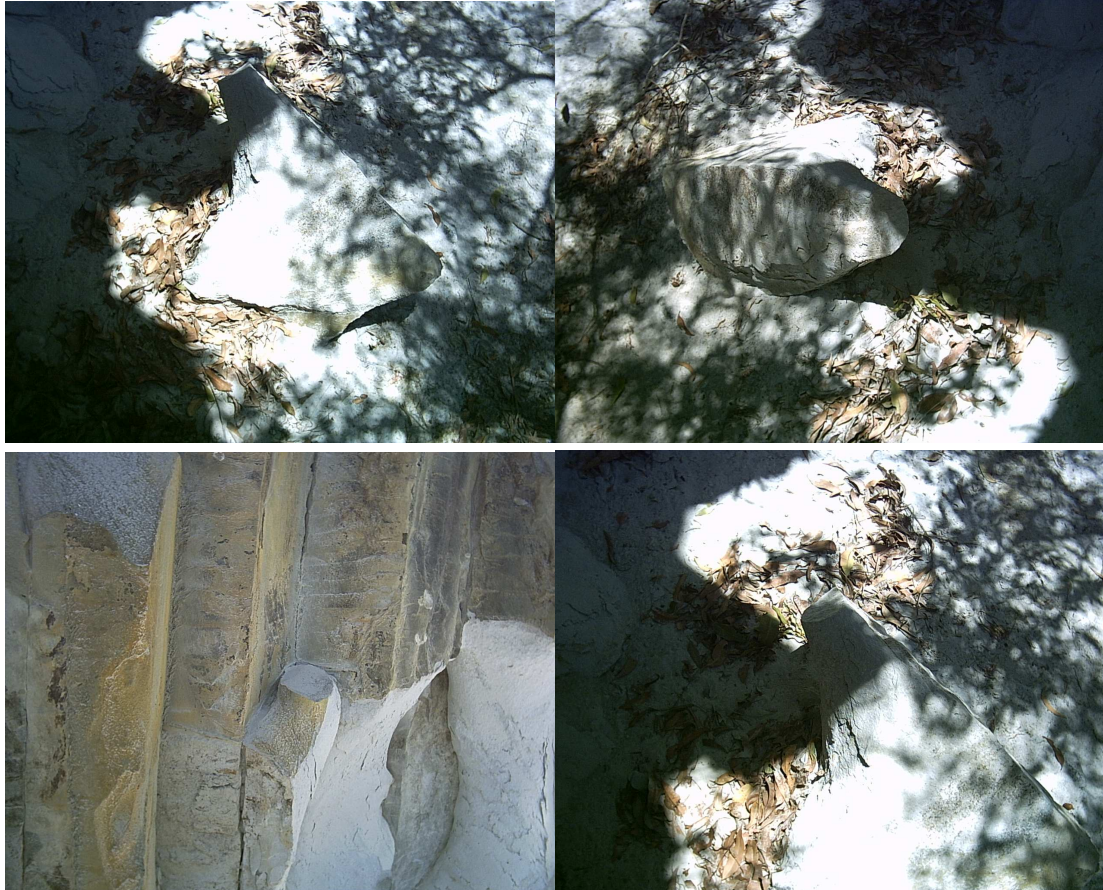
A piece, approximately 0.080 m<sup>3</sup> (est 0.5x0.4x0.4), was found on the ground at the East caves on 2009-07-26, approximately 1m from the cliff base. It had fallen within the recent year, as it had not been observed on the ground prior to this visit. This had fallen from a height of less than 1m above ground level as it was a weathered obelisk that had eroded at a neck and finally snapped off, possibly under its own weight once the neck of the pillar was thinned down to the small area shown below.

Figure 99. Montage - Fallen Block, East face

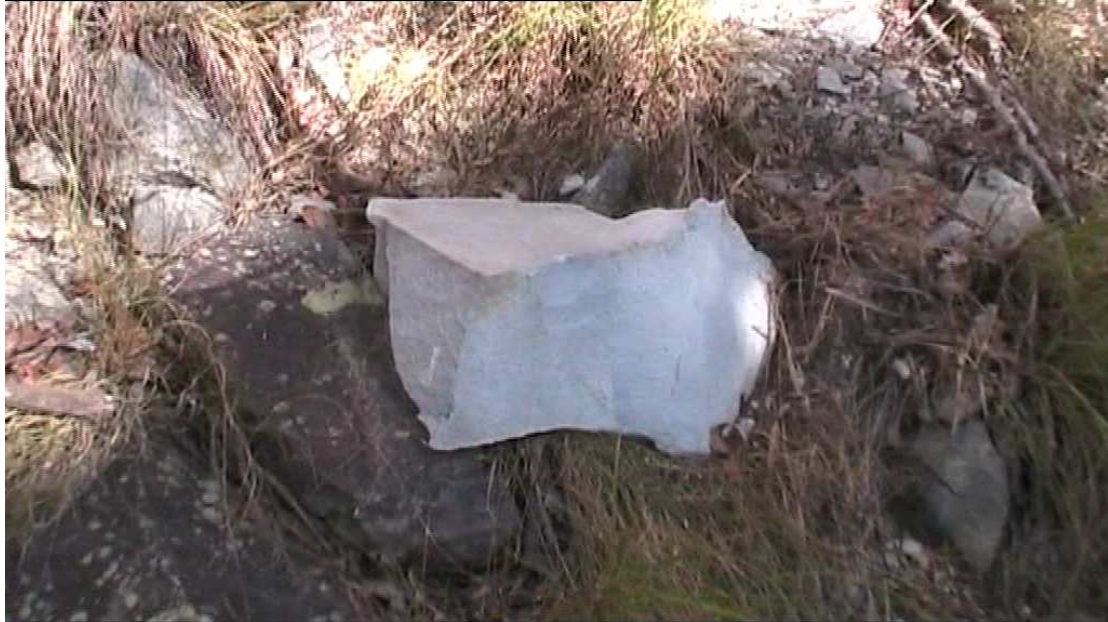
A piece, approximately 0.024 m<sup>3</sup> (est 0.4x0.3x0.2), was found on the ground at the North East corner on 2009-07-26, approximately 2m from the cliff base. It was estimated to have fallen within the previous fortnight, as the grass beneath it was still dying from light starvation.

**Figure 100. Fallen block, East face**

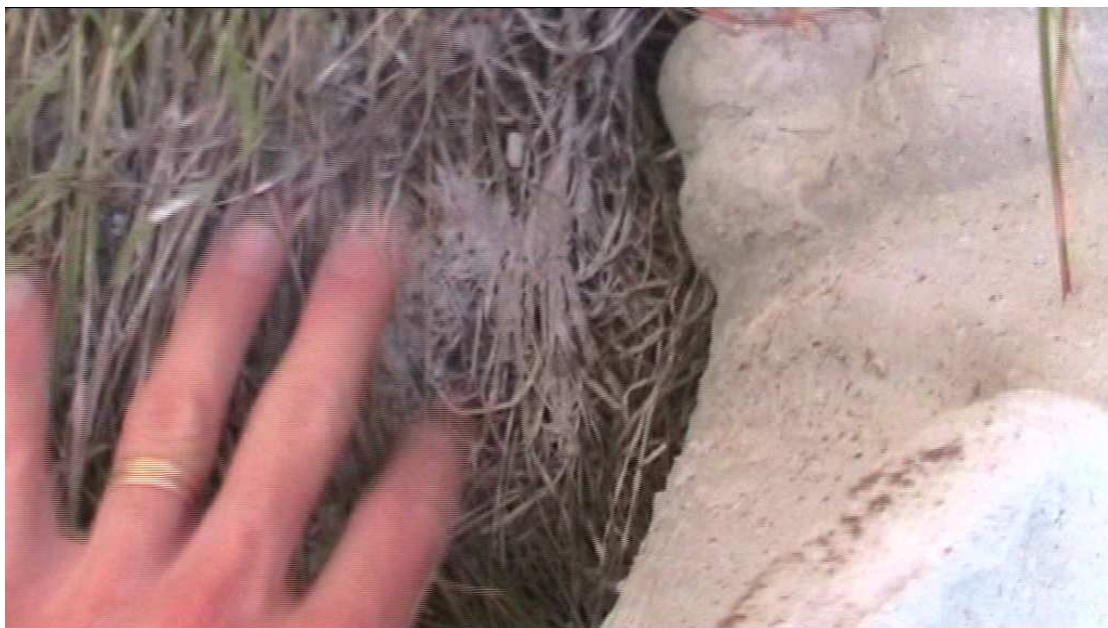
**Figure 101. Grass decaying**

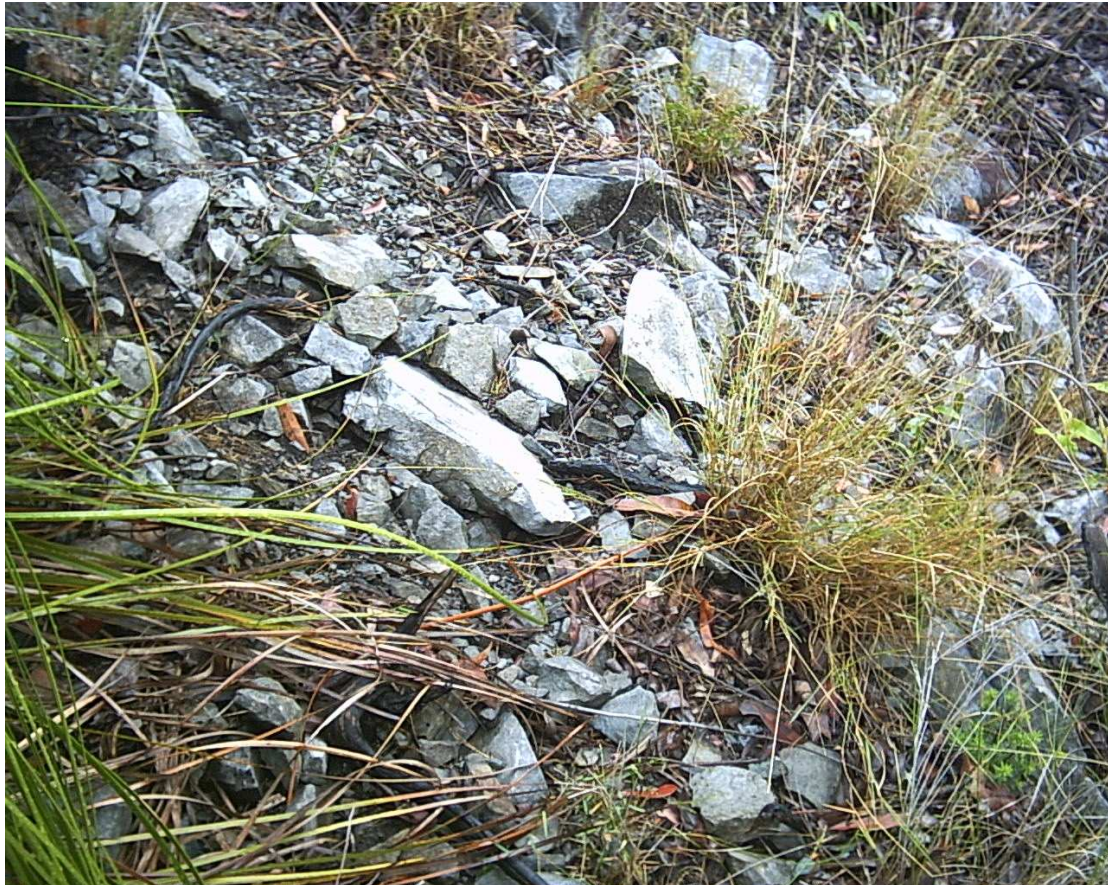
Numerous small pieces of broken rock of indeterminate age were found beneath the North face cave (“Mank Master”) on every trip, as was the case also during the 1990’s. This is the consequence of the erosion and strain patterns observed in later visits that examined the internal structure of the North face cave. This rock can be considered to be falling fairly frequently, due to the nature of the continuous erosion in the cave. It could be estimated within Coffey’s original decay frequency that a small fall of a single saucer-sized rock or two might occur once a month. It is also more likely that this might occur during high winds, heavy rain, or during any earth tremor, as the mouth of the cave depicted above serves as a “brimming-full dam” of these shards of rock and cave dust. Any new falls inside the cave first fall onto this perched pile of dust and scree, and some may then fall from the edge of the “dam”. This cave is inaccessible to anyone without comprehensive rock-climbing skill and equipment, and as a climbing route it is unattractive in the common sense, being troublesome and extremely “boutique”, so there is a minimised chance of people increasing this displacement of rock to the ground below.

Figure 102. Scree below North cave

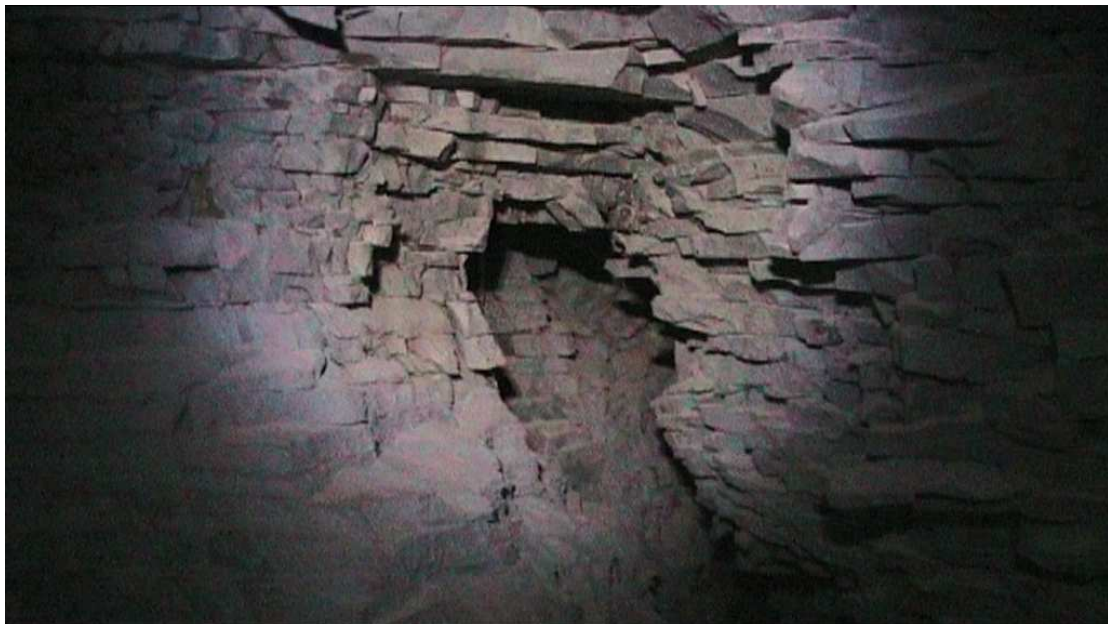
And inside the cave, there are numerous (perhaps a dozen) features that present as contributory sources of the flow of rock emitting from the mouth of the cave. This is a sample.

**Figure 104. Rock formation inside the North cave**

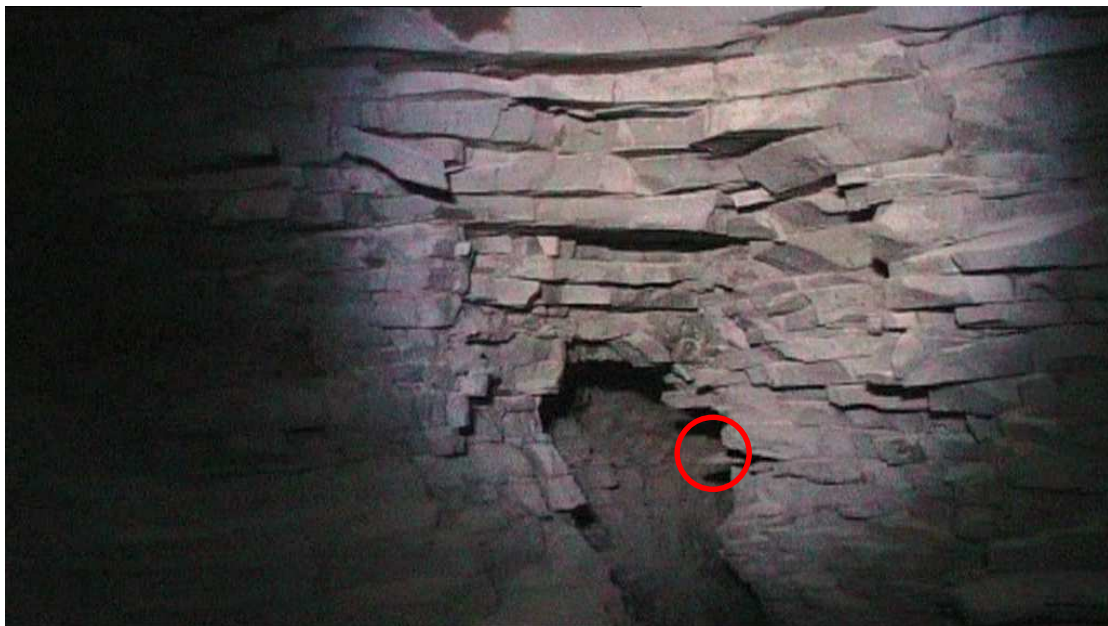
Comparative photos were taken three months apart in 2009, and the feature was unchanged except for the loss of one plate of rock, circled below.

**Figure 162. The archway of perched "shale" plates at the top of the rear of the cave**

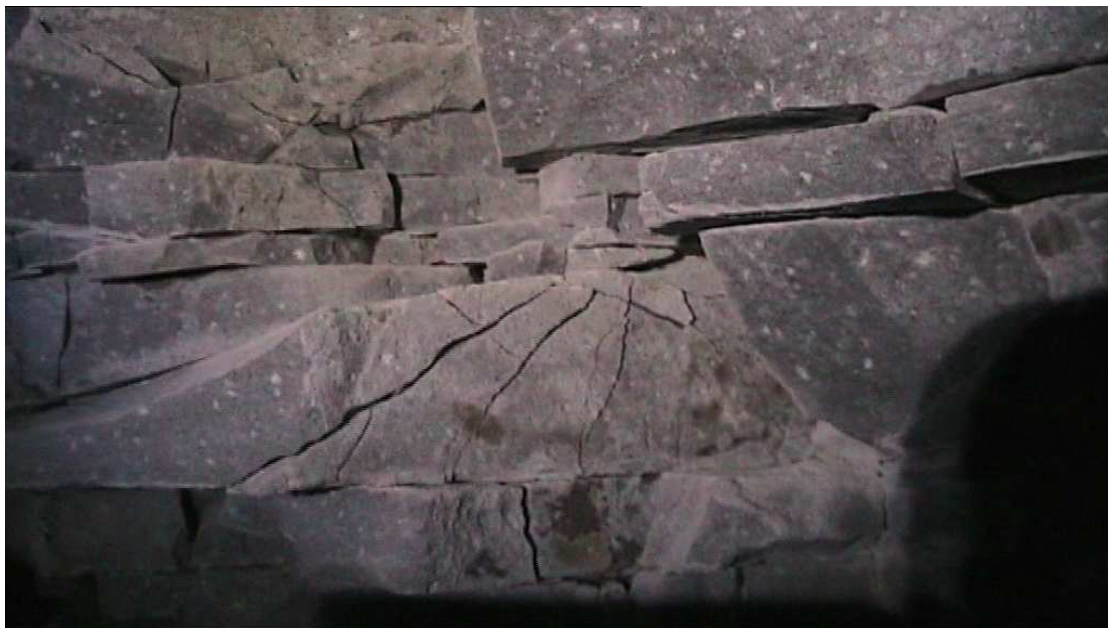
**Figure 164 A stress cracking pattern identified to the right of the archway of perched shale plates at the top of the rear of the cave**

This cracking feature was singled out by a consulting geologist as being of special significance regarding the stresses being put on this location by Coffey’s block. The impression made upon the author by the geologist was that this archway of stacked plates and the stress cracking shown here in them indicates a focal point of the geo-mechanical stress resulting from the restraint of Coffey’s block, and monitoring of this feature would be of very high interest in improving understanding of the geo-mechanics in action.

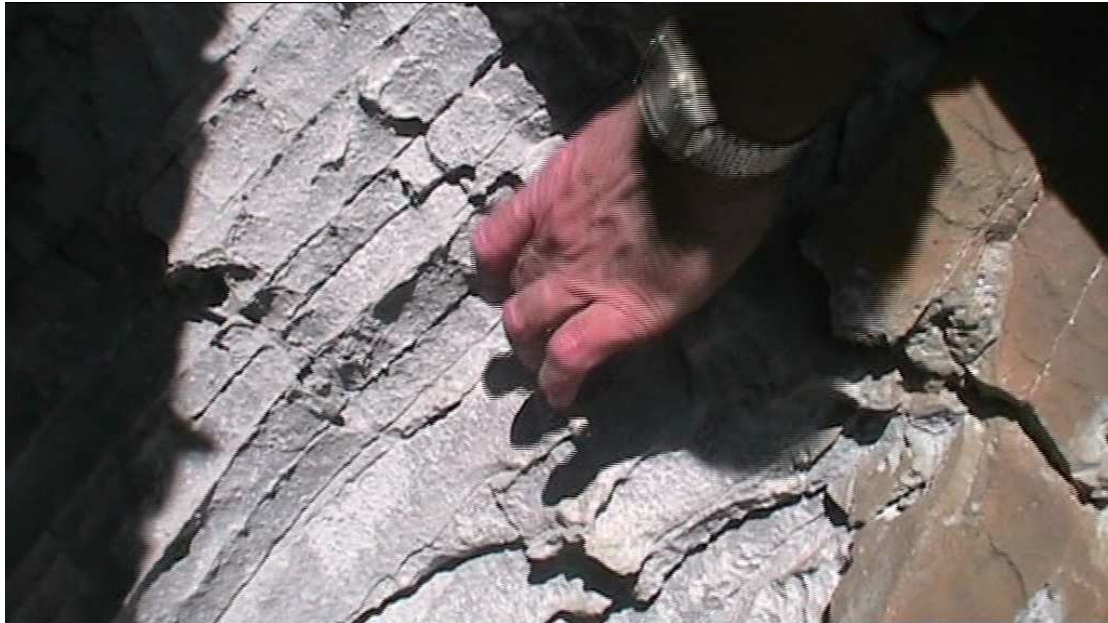
**Figure 167. Outside the upper mouth of the Mank Master cave - Rapidly eroding soft powdery rock, decaying behind a surface of brown mineralisation**

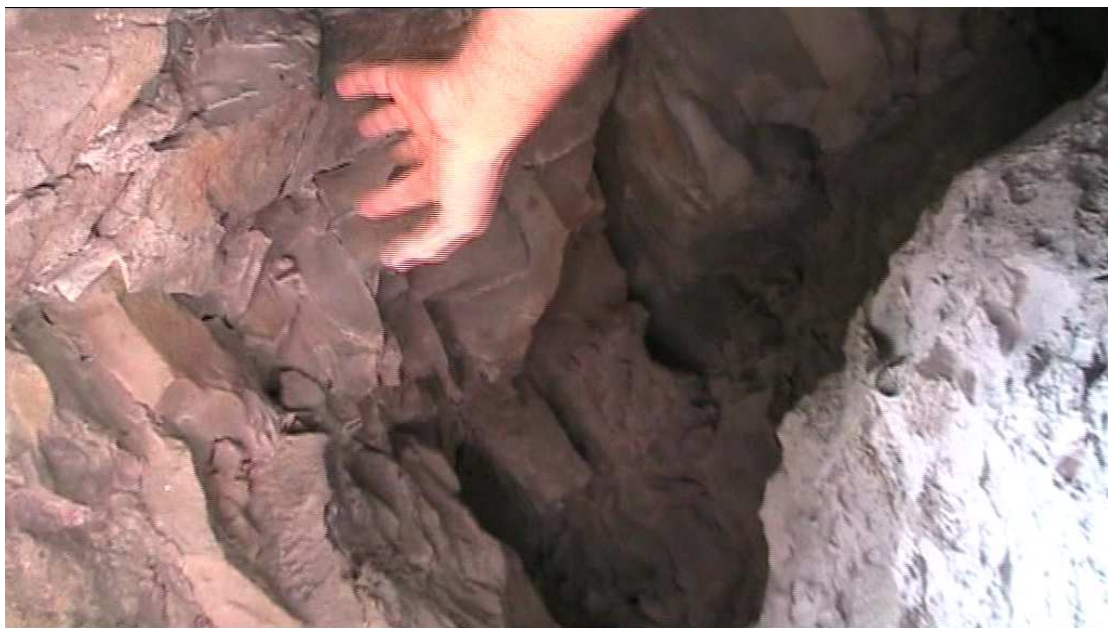
**Figure 168. Outside the upper mouth of the Mank Master cave - Brown mineral crusted rock to the left, soft eroding powdery rock to the right, in the second upper mouth of the Mank Master cave**

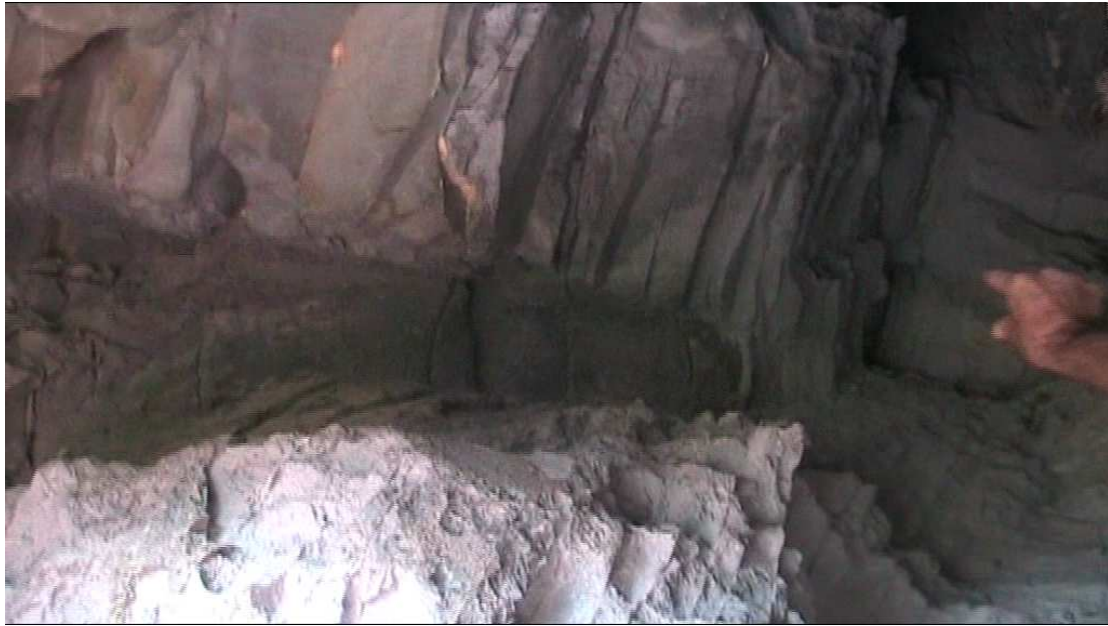
Figure 169. Outside the upper mouth of the Mank Master cave - Bands of harder and softer rock eroding in layers, in the second upper mouth of the Mank Master cave

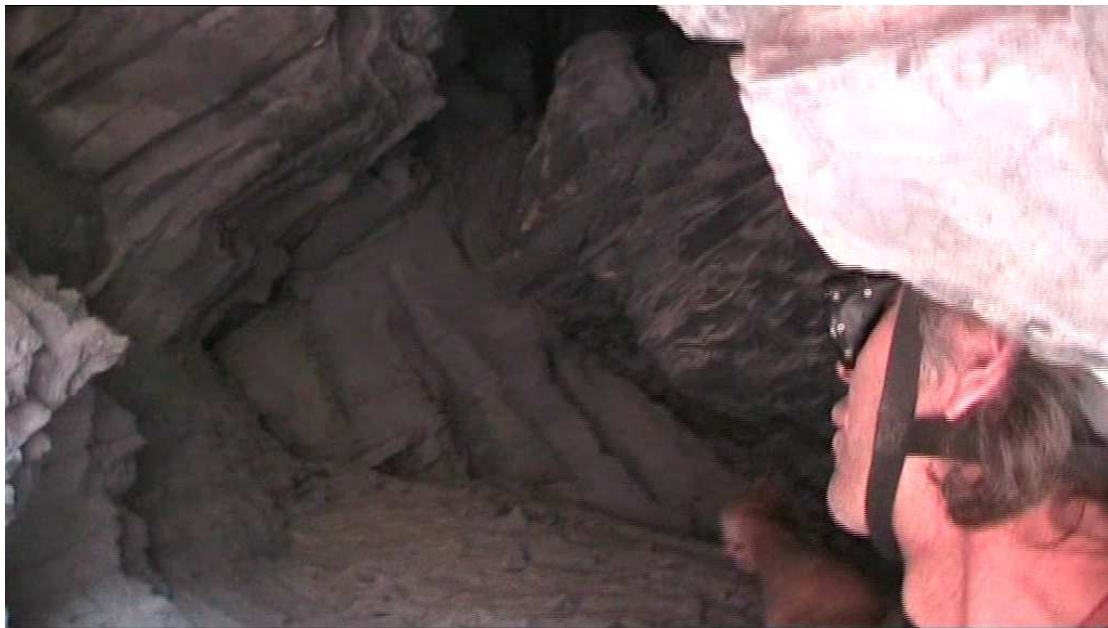
Figure 170. Outside the upper mouth of the Mank Master cave - Bands of harder and softer rock eroding in layers, in the second upper mouth of the Mank Master cave
